## Technical Service Bulletin 020709

### Crowbar Retrofits and Procedure

This service bulletin concerns all Comark IOX, Advantage, DCX, and DCX Millennium transmitters.

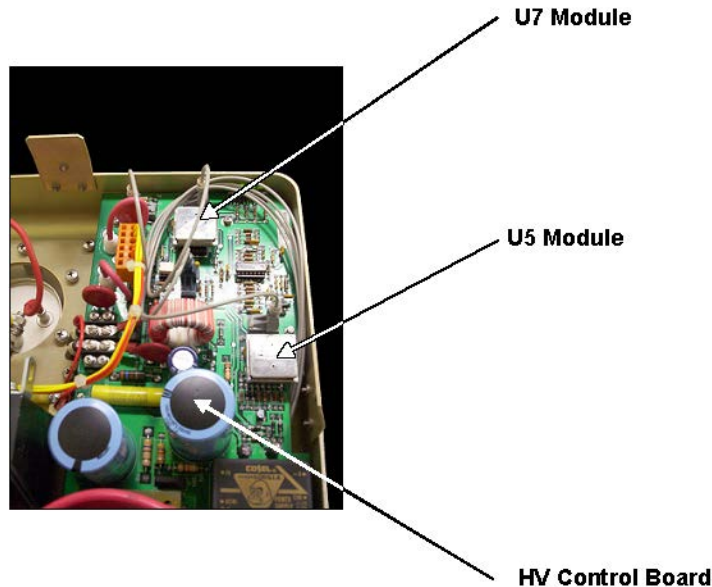
A critical part of the upgrades described in this document are the U5 (P/N 46744258) and U7 (P/N 46744352) retrofit modules installed on the Crowbar HV Control board. These modules specifically address a problem in which the crowbar logic "freezes" after a firing, thereby preventing the crowbar from reporting a "ready" signal to the HPA control system. Upon closer inspection of the crowbar assembly, one or several of green indicator LEDs on the upper (HV) half of the crowbar are extinguished or glowing dimly.

Please find attached the document *46744354-328 Retrofit Procedure, Thyatron Crowbar*, an extensive procedure detailing what steps are required to update older crowbars to current revision levels.
