Technical Service Bulletin 040407**HVPS Door Gasket**

This service bulletin affects all Comark IOX, Advantage, DCX, DCX Millennium, and DCX Paragon transmitters. The high voltage beam supplies provided with these transmitters feature a door gasket design that may be prone to failure in the field over time. This failure typically manifests itself as the infiltration of outside rain water into the air compartment of the beam supply. The result is a standing pool of water, which, if not addressed promptly, may lead to the failure of the fiberglass resistor support board, as previously addressed in Service Bulletin 030514 *HVPS Resistor Board*. An increased incidence of rust and other failures may also occur.

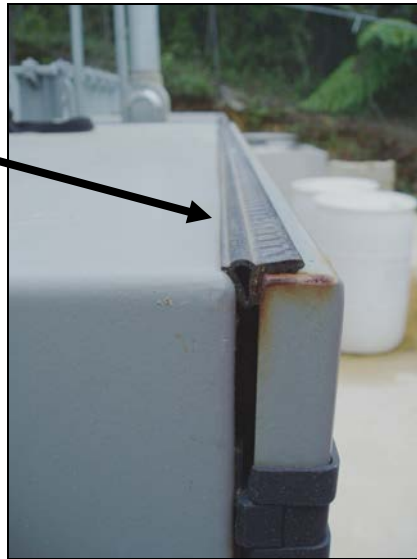
Snap on gasket

(essentially applies to all beams supplies produced after 1995)

To eliminate this problem, Comark is offering a door gasket retrofit: P/N 609090-01 (contact Comark customer service for price and availability). The applicability of this retrofit to a particular beam supply may be determined by consulting the photograph below.
