1. USE THIS PROCEDURE TO TROUBLESHOOT PROBLEMS WITH THE THYRATRON CROWBAR (PART NUMBER 451227-01). IT IS NOT ALWAYS NECESSARY TO RETURN THE CROWBAR WHEN IT FAILS. IT IS POSSIBLE TO TROUBLESHOOT MANY PROBLEMS WITH THIS ASSEMBLY IN THE FIELD.
2. OBEY ALL WARNINGS AND PRECAUTIONS MENTIONED IN THIS PROCEDURE.
3. THE IC'S REFERRED TO IN THIS PROCEDURE CAN BE PURCHASED AS A KIT. ORDER KIT #46744355.
4. WHEN RETURNING A CROWBAR FOR SERVICING, IT IS IMPORTANT TO CONVEY THE SERIAL NUMBER AND A DETAILED PROBLEM DESCRIPTION TO THALES PERSONNEL FOR TRACKING PURPOSES.

B	ECO#5094	AMM	10/10/03	GDC	10/16/03	REVISED FOR U7 MODULE		
A	~	AMM	08/07/03	AMM	8/7/03	ENGINEERING RELEASE		
REV	CHG. ORDER	ISSUED	DATE	AUTH.	DATE	DESCRIPTION		
ISSUED	A. MASIUNAS	08/01/03	PROJECT NO.		ELECTRONIC FILE:			
CHKD	G DelCAMPO	8/7/03			46744354-194B.doc			
ENG	A MASIUNAS	8/7/03	TROUBLESHOOTING PROCEDURE, THYRATRON CROWBAR					
ENG	D SPARANO	8/12/03						
MFG	T JERARD	8/7/03						
EDC	V CRUZ	8/12/03						
THOMSON			DOCUMENT NUMBER		DTC CODE	SIZE	PAGE	
			46744354		194	A	1/11	
OFFICE RESP. <i>Southwick, MA</i>							B	REV A

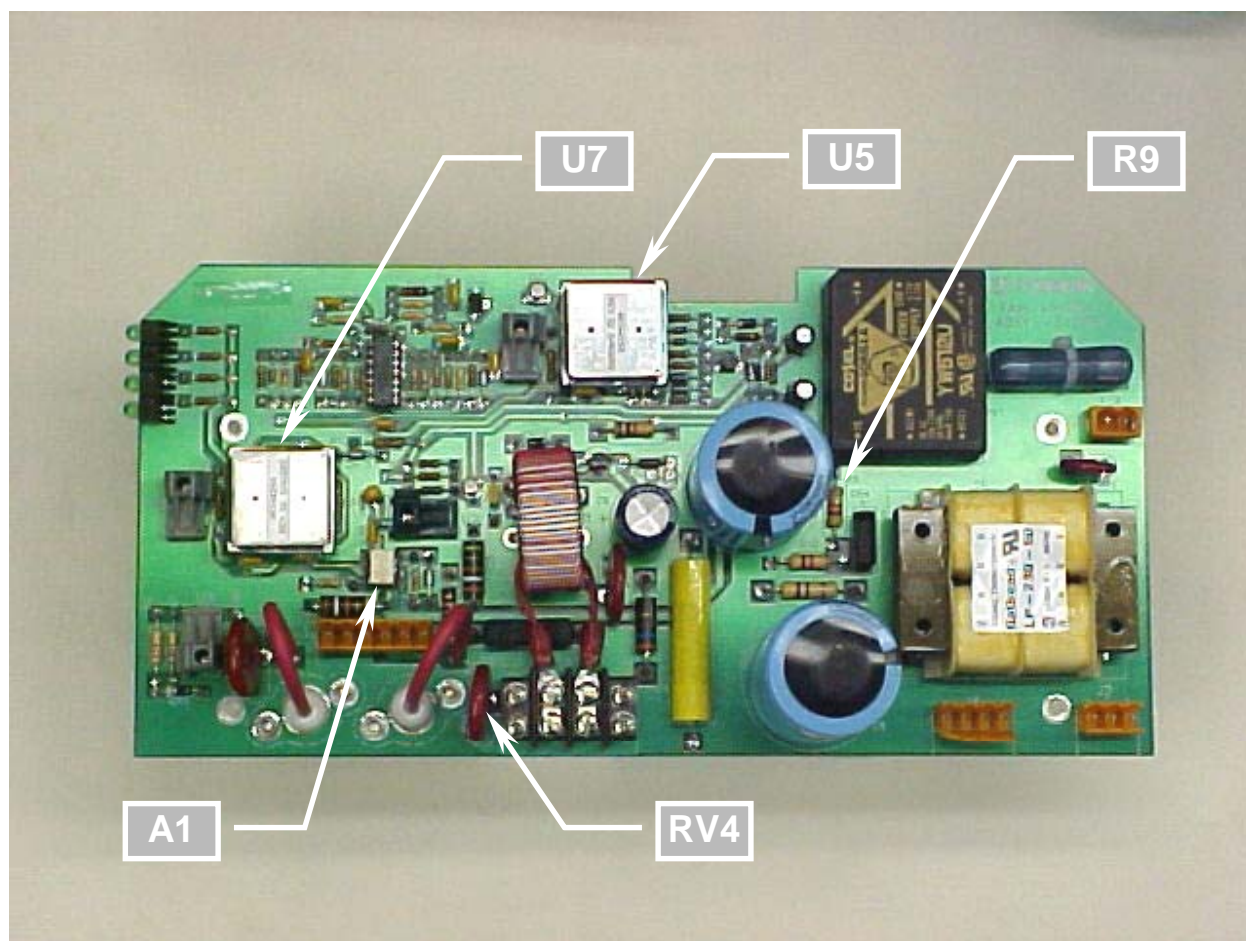
Figure 2: HV Control Board

If all of the lights on the top (HV) section of the crowbar are out, and/or the 'BIAS READY' on the lower (LV) section is out, replace U7 (P/N 46744352) on the HV control board. If the problem still exists, replace U5 (P/N 46744258) on the HV board.

If only the 'GRID 1 I' and 'BIAS READY' lights are out, check that the thyatron does not have an open filament. To do this, disconnect the filament (yellow) lead and measure the resistance between it and the top case. If the thyatron filament is good (approximately 4Ω), replace A1 (P/N 603976-01) on the HV control board. If the problem still exists, replace U7 (P/N 46744352) on the HV board.

If only the 'GRID 1 V', 'GRID 1 I', and 'BIAS READY' lights are out, check the supply for grid 1. The voltage out of this supply, as measured across R9, should be over 120Vdc. If the bias supply is good, replace U7 (P/N 46744352) on the HV control board.

If only the 'GRID 1 V' and 'BIAS READY' lights are out, replace U7 (P/N 46744352) on the HV control board.

If only the 'GRID 2 V', and 'BIAS READY' lights are out, check the supply for grid 2. The voltage out of this supply, as measured across RV4, should be over 120Vdc. If the bias supply is good, replace U7 (P/N 46744352) on the HV control board.

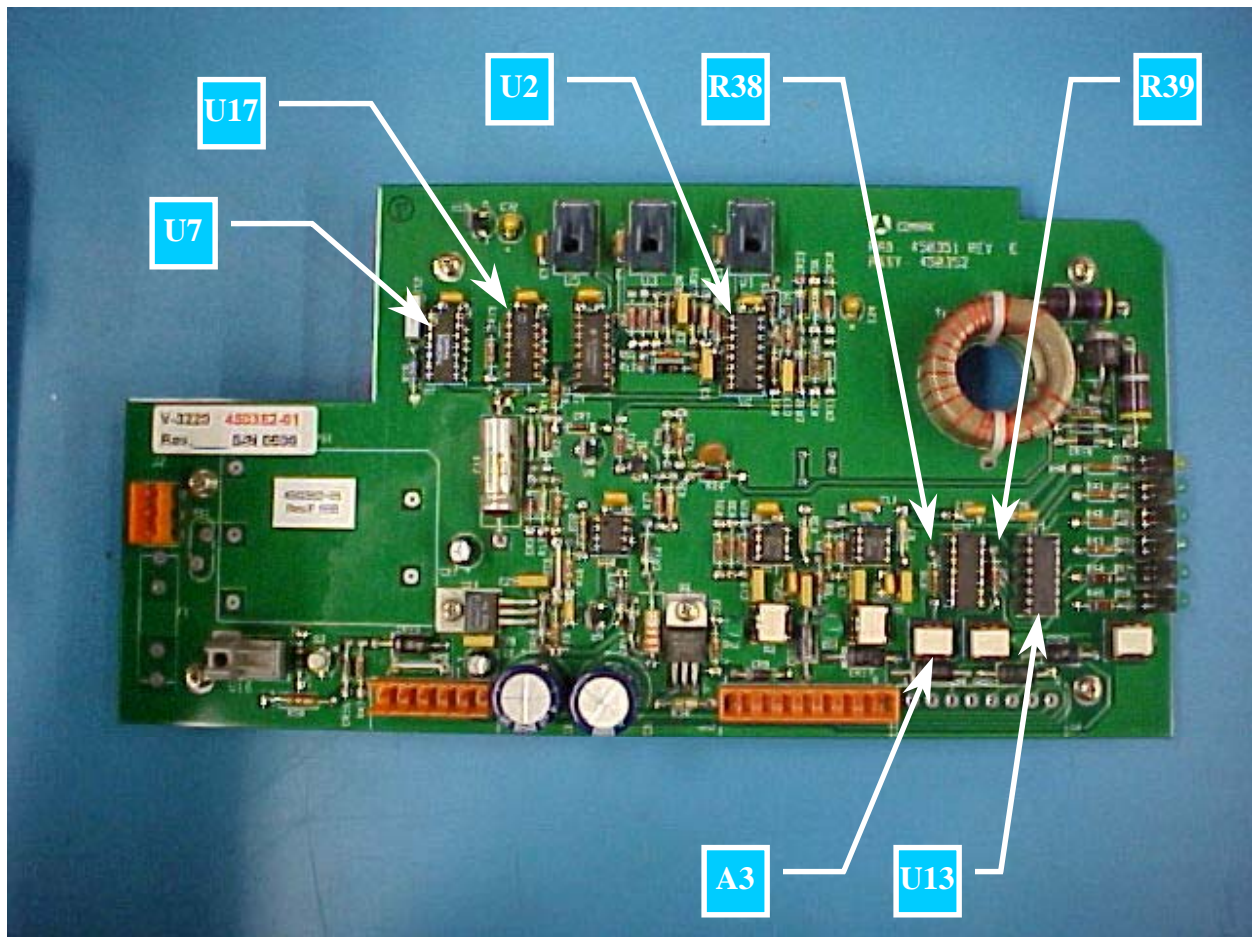
Figure 3: LV Control Board

If only the 'FILAMENT ON' and the 'FILAMENT TIME DELAY' and/or the 'NOT FIRED' lights are out, replace U2 (P/N 701021-01) on the LV control board. If the problem still exists, replace U13 (P/N 601510-01) on the LV control board.

If only the 'FILAMENT TIME DELAY' light is out, replace U7 (P/N 604348-01) on the LV control board. If the problem still exists, replace U17 (P/N 604925-01), and then replace U13 (P/N 601510-01) on the LV control board.

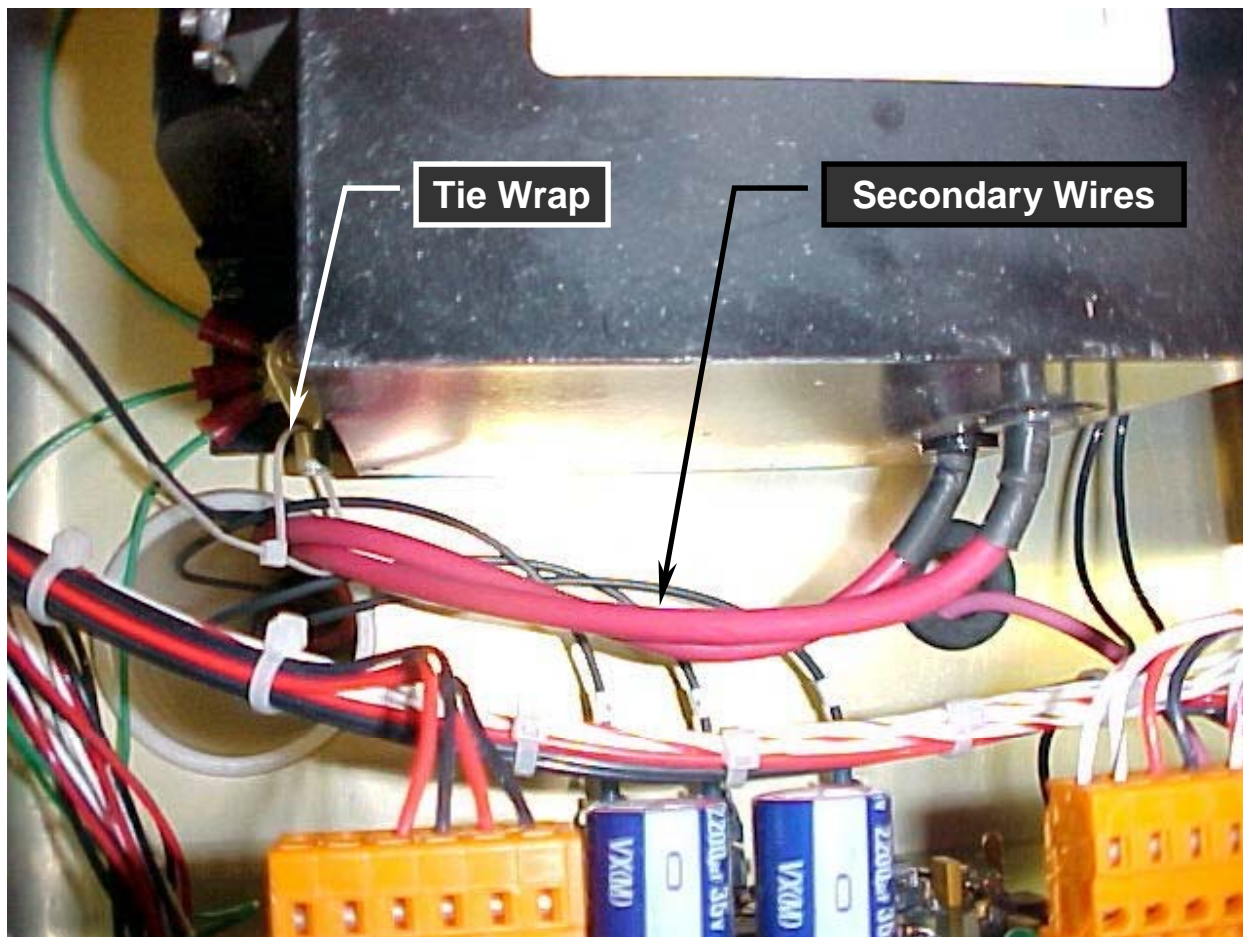
Figure 4: Transformer Secondary Wire Routing

If the crowbar loses ready when high voltage is applied, but does not actually fire, remove the crowbar and check the routing of the high voltage wire from the secondary of the isolation transformer. If these wires touch the low voltage control board, or are within roughly a half-inch of the board, the electrical field of the wire can affect the control circuitry. If this is the case, tie the wire back from the low voltage board by securing them to the transformer's mounting stud with a tie-wrap.

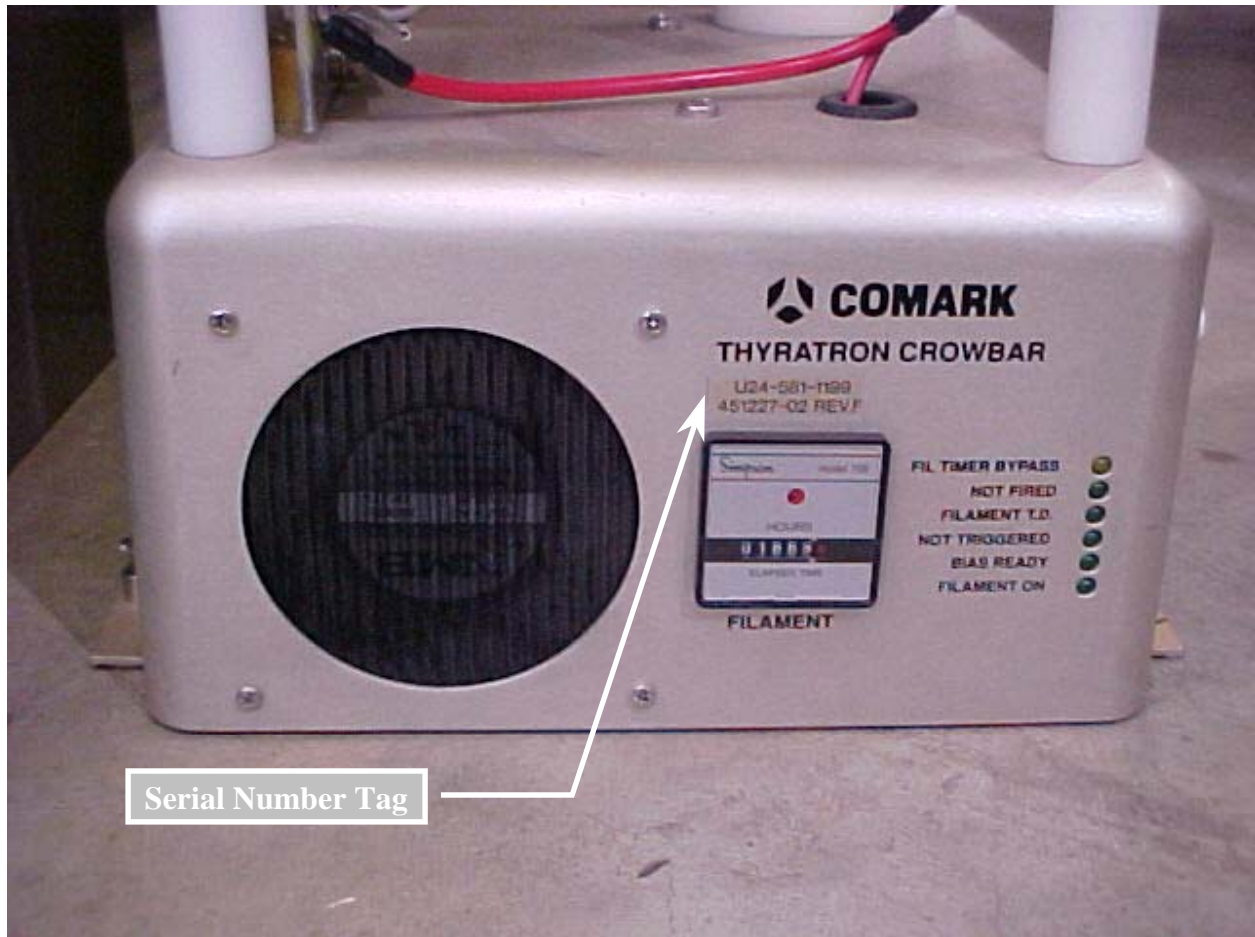
Figure 5: Front View of Crowbar Showing Serial Number Tag.

If the crowbar comes ready in less than ten minutes, the HPA may have the wrong version of the crowbar. Look at the serial number tag on the front of the lower section, as shown in Figure 5. For IOX and DCX cabinets, the part number on this tag should be 451227-01. Replace the crowbar if the tag is marked 451227-02, it is the wrong version. The 451227-02 version is for Advantage cabinets only.
